HP L2035 Flat Panel Monitor Recall

PHILIPS ELECTRONICS SAFETY RECALL NOTICE

PROBLEM: A ground clip incorrectly installed within the inside back plastics panel of the monitor, posing a potential for an electric shock hazard.

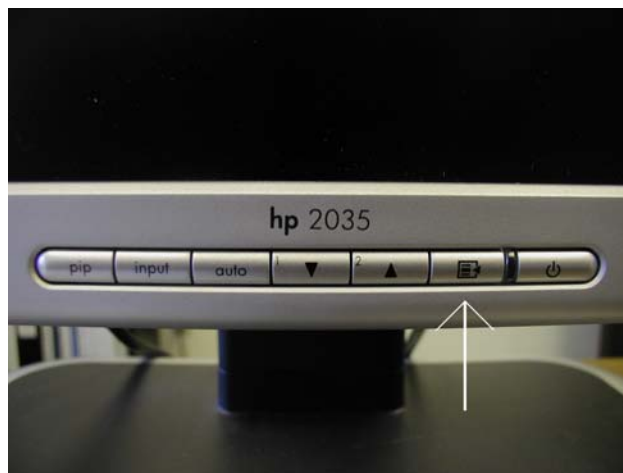
1. Press the Menu button (Located to the immediate left of the Power LED indicator)

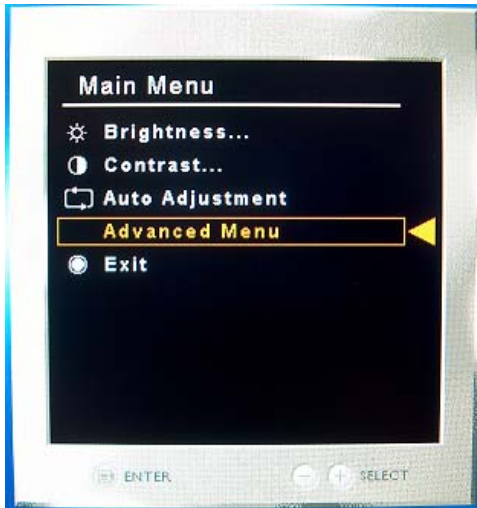
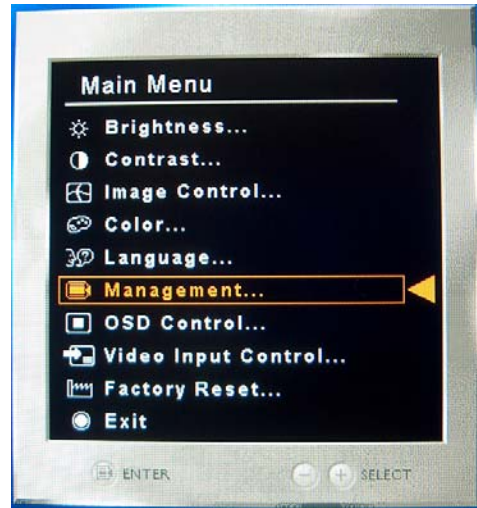
1. Select the Advance Menu option.
2. Press the Down Arrow button five (5) times and select the "Management" option.

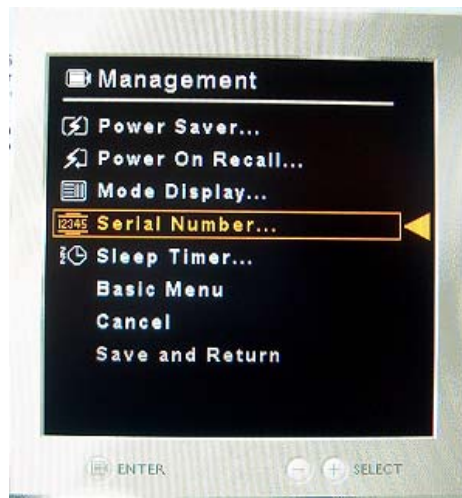
3. Press the Down Arrow button three (3) times and select the "Serial Number" option.

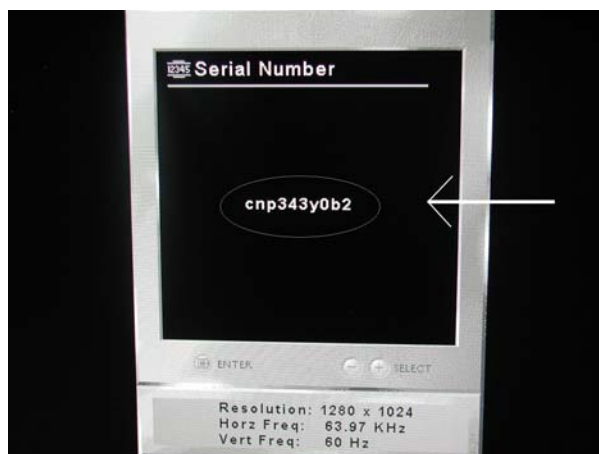
4. The Serial number will now be displayed. Please document this serial number and check to see if it falls within the affected serial number range listed above.

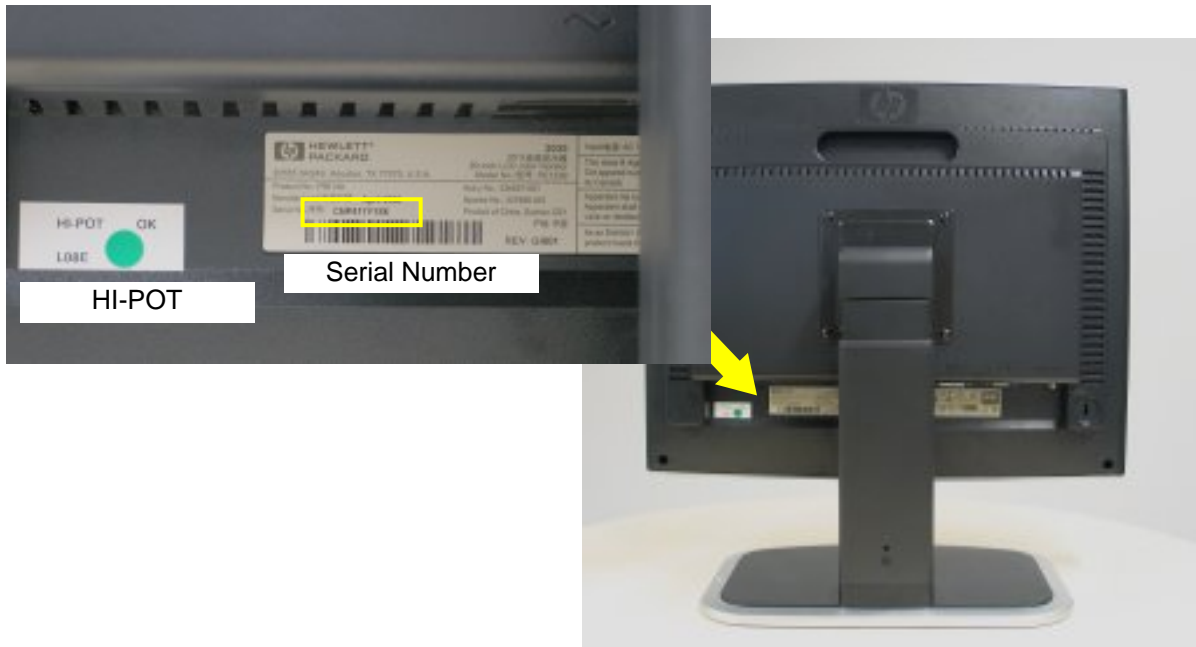
1. **UNPLUG THE POWER CORD FROM THE WALL** before proceeding.
2. Check the serial number on the back of the monitor to see if it is in the affected range.

If your monitor is within the affected serial number range, check for a Green dot (sticker) on the back of the monitor near the HI-POT label. Be sure to **unplug the power cord from the wall**, before checking the rear of the monitor. If a Green dot is present, this will identify that the monitor is not affected and no action is needed. If a green dot is **NOT** present contact the HP L2035 Recall Helpdesk at the Telephone number listed.

- If you determine that your monitor may be affected, leave it unplugged, and contact your **local HP L2035 Recall Helpdesk**. A technician may be dispatched to your location for onsite testing or a replacement L2035 monitor may be provided.
- We strongly recommend you keep the monitor unplugged. However, if you choose to continue to use the monitor, please review the hazard described in the **Problem** description above or in the Frequently Asked Questions (FAQ) Question 4.
- If your serial number is **NOT** in the affected serial number range, or if a green dot is present on the back of the monitor, **no action is required.**
